Manhole Inspection Summary

Manhole # S35W__026MH

Insp Date: **2/11/08 4:05 PM**

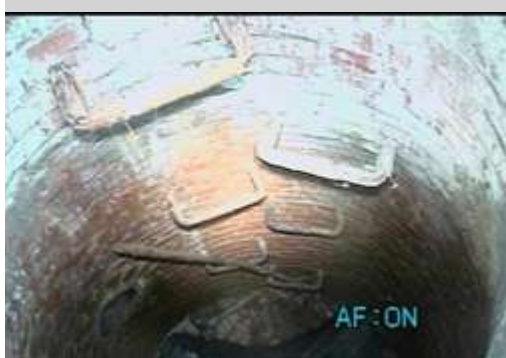
Defect 3

Count: **6** Missing: **0** ☒ **Corroded**

corroded steps

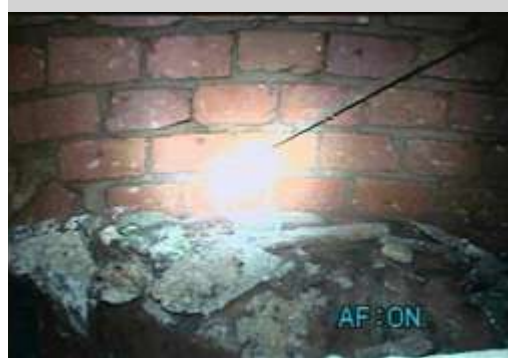
Defect 2

Condition: ☐ Sound ☐ Cracked ☐ Root Intrusion ☐ Deteriorated ☐ Leaks ☒ **Debris**

bench debris

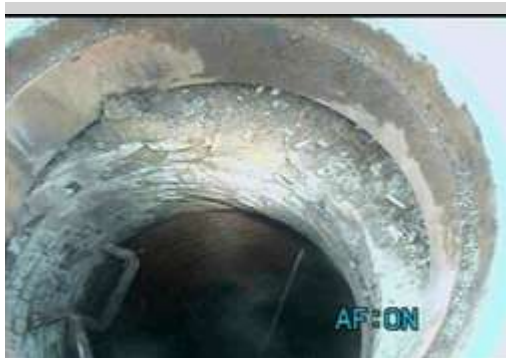
Defect 1

Offset: **4** (in.)

Condition: ☐ Sound ☐ Cracked ☐ Root Intrusion ☐ Loose Brick ☒ **Deteriorated**

frame offset, deteriorating corbel

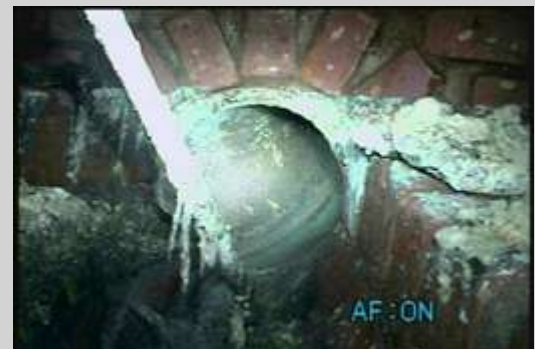
Drop In @ 4 O'Clock

Drop: Inside Direct
Angled: Reading: 0.00 (ft.)
Inv Depth: 10.30 (ft.)

Drop Condition: Partly Clogged
